FOREST RESOURCES ASSOCIATION INC.

SAFETY ALERT

16-S-1

OVERLOADED LOG TRUCK TRAVELING TOO FAST

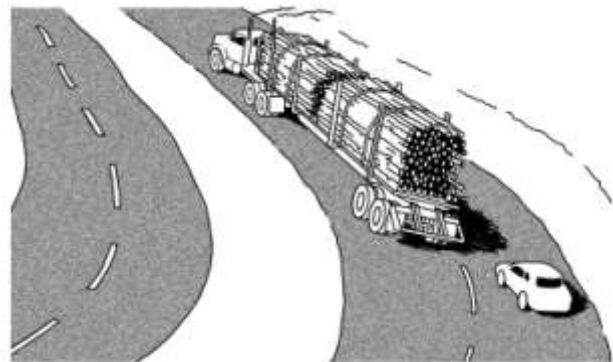
UNSAFE ACTS AND CONDITION: The speed limit was 35 miles per hour, and in the estimation of the foresters, the log truck was overloaded and was exceeding the speed limit. As the truck went into the curve, the trailer began leaning hard to the right—towards the outer lane of traffic where the passenger car was.

ACCIDENT (CLOSE CALL): The driver did not slow down in the curve, and the trailer leaned farther and farther to the right. Both foresters expected the tractor-trailer to tip over and anticipated that the car directly behind it would smash into the truck—and that a serious wreck would result.

INJURY: Fortunately, the trailer did not tip over, and the driver was able to maintain control and continue on. The foresters noted that had one wheel edge of the log trailer run up against the median strip while negotiating the curve, the trailer would almost certainly have toppled over.

The foresters drove to the mill after lunch and reviewed the pictures that their mill's cameras had taken of each truck at the scales. They found the truck that they had seen and noted that the load was excessively overweight. They were able to determine the wood supplier for whom the trucker hauled and planned to contact the supplier to discuss the unsafe actions they observed (and to remind the supplier about the mill's overweight load follow-up/penalty policy).

- Drivers must follow posted speed limits for the roads and conditions they encounter. Depending on the load's center of gravity and other load and road conditions, traveling right at the speed limit may still be too fast.

- Drivers should be trained to understand load dynamics and center of gravity. A double-bunk load can be more susceptible to rollover than a treelength load because the back bunk typically is fully loaded and the gap between the two racks of wood makes it easier for the log trailer to flex.

- Overloading a log trailer can result in unsafe handling conditions and presents a hazard to the truck driver and others on the highway.
- Many logging and trucking contractors use on-board or portable platform scales to ensure they do not haul loads that exceed the state weight limits.
