**DASH CAMERAS CAN IMPROVE SAFETY AND REDUCE LIABILITY**

*Safety: Transportation*

*February 2015*

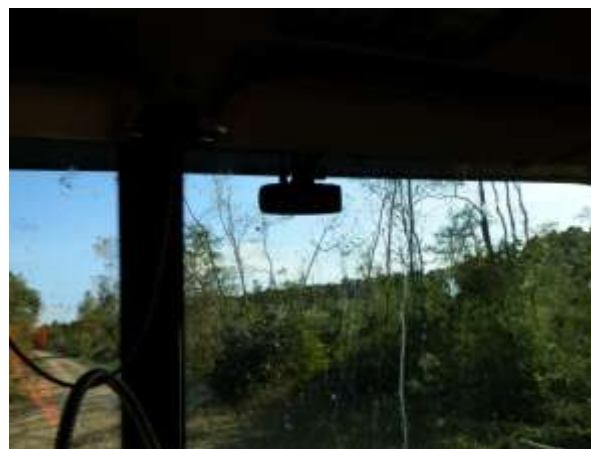
*Fig. 1: Dash Cam is inconspicuously mounted near the top of the windshield on the passenger side.*

Dawg GPS 1080P DVR Dash Cam (see <http://www.topdawgelectronics.com/top-dawg-gps-1080p-dvr-dash-cam/>). We elected to install the cameras on the passenger-side windshield with a tamper proof mount and cable, although these cameras may be installed just by plugging them into a cigarette lighter.

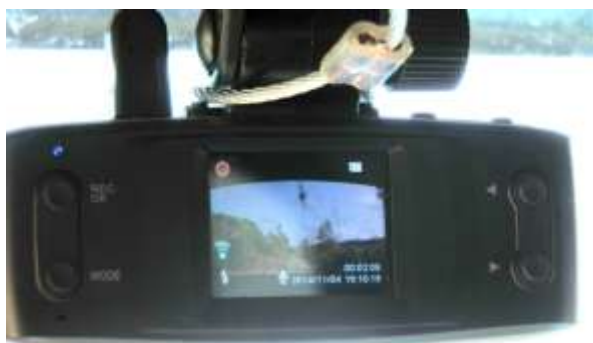
*Fig. 2: The video camera "sees what the driver sees" through the windshield.*

This camera records the driver's view and even has audio to record everything on a driver's shift. GPS on this system has the ability to track video playback with Google Maps, showing the truck's location as well as its speed and direction. The video is recorded on a micro memory card in AVI format, suitable for playing back on a PC, laptop, or TV using the AV cable, the included HDMI cable, or USB 2.0 cable. This camera also features G-sensor technology, which can detect an impact or collision and will automatically save and lock the video file recorded 20 seconds prior to and after the impact onto the SD card.

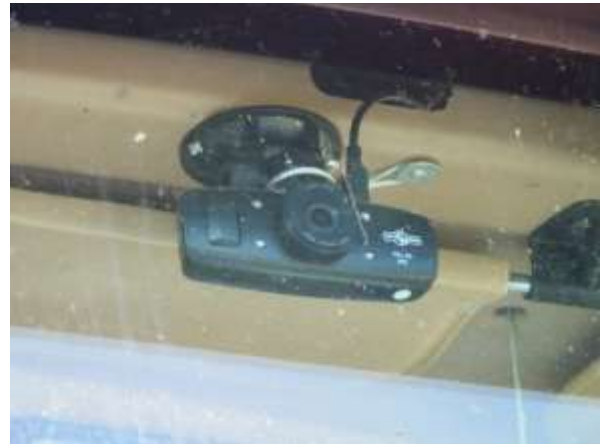
*Fig. 3: Dash Cam lens faces out through the windshield.*
